| <b>Property</b> | 2 Bedroom Apartment, Tower B, Level 14 |
| <b>Community</b> | Dubai Hills Estate, Dubai |
| <b>Report reference</b> | WSN-SAMPLE-0914 |
| <b>Inspection type</b> | Pre handover snagging, thermal imaging included |

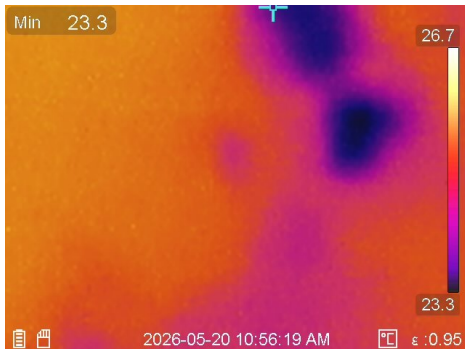
## Concealed moisture, master bathroom

| # | Location | Finding | Grade | Recommended action |
|---|---|---|---|---|
| 01 | Master bathroom | Thermal scan shows active moisture behind shower wall, no visible surface sign | CRITICAL | Open and trace leak, re waterproof, retest before close |

The cool blue plume behind the shower wall marks trapped moisture with no visible surface sign. Left unresolved this tracks into adjacent rooms. Logged as finding 01, critical.

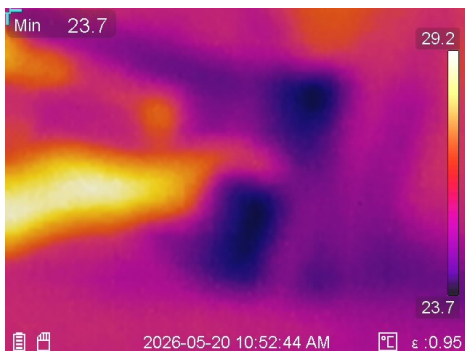
## Overheating circuit, distribution board

| # | Location | Finding | Grade | Recommended action |
|---|---|---|---|---|
| 02 | Distribution board | Two circuits running hot on thermal, loose termination suspected | CRITICAL | Isolate, re terminate, thermal retest under load |

The bright signature shows a circuit running hot against its neighbours, consistent with a loose termination. A fire risk that must be corrected before handover. Logged as finding 02, critical.

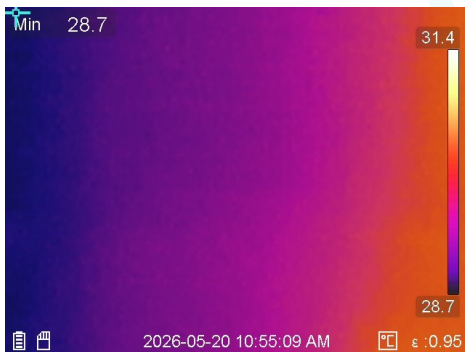
## Moisture migration, ceiling junction

Cooler tracking across the ceiling junction shows water moving from the wet area above. Confirms the path of a leak and where to open up. Supports the wet area findings.
